Ford Heated Seat Button Repair Kit

by x8rltd

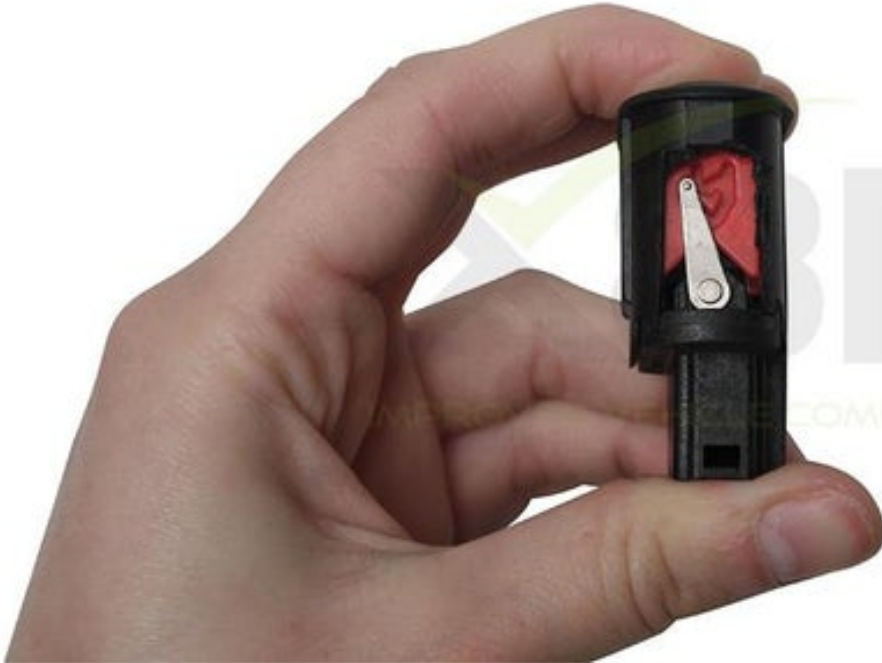
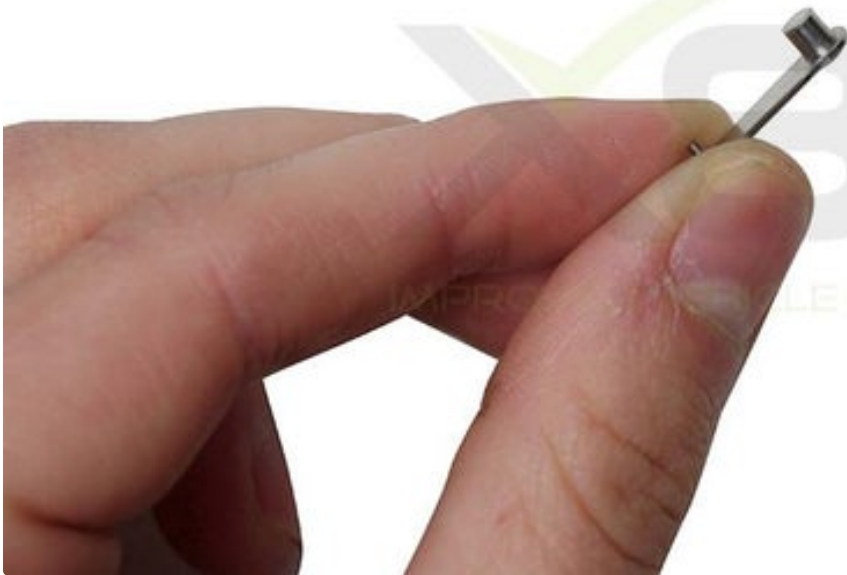
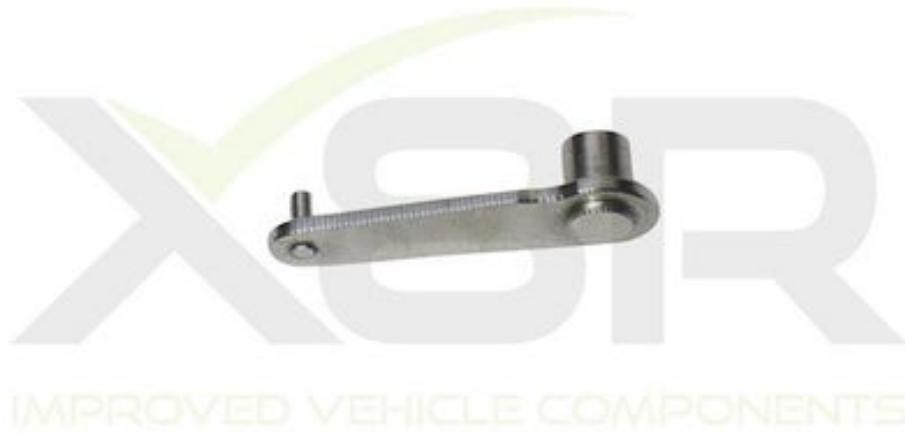
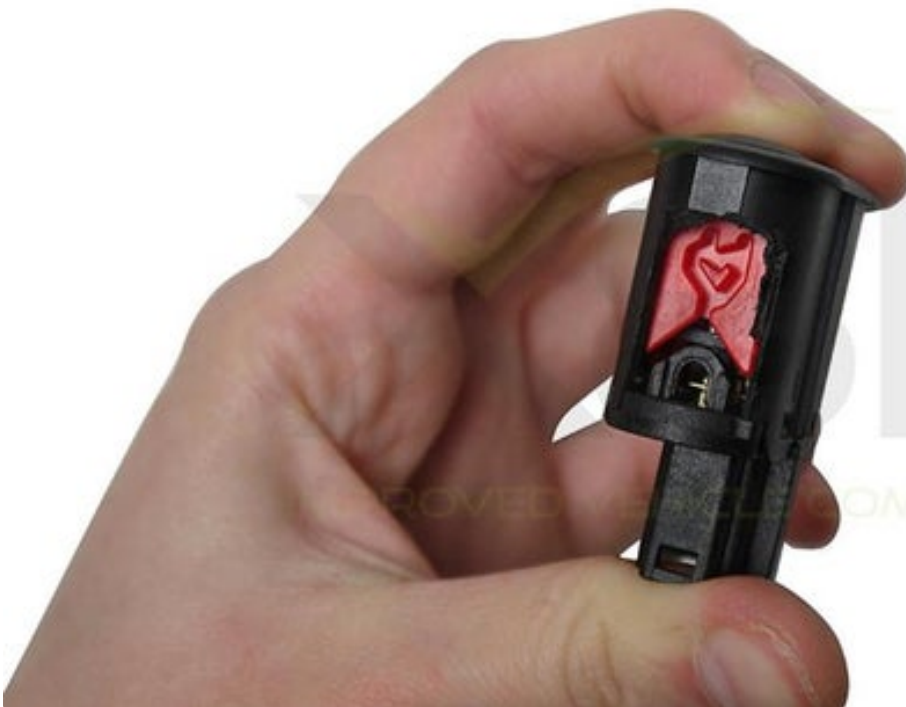
The heated seat switch on various Fords become inoperable due to the metal bracket that guides the button up & down can break or bend. The small connectors can snap off, the bracket itself can bend/misshapen, or the whole bracket itself could snap in half. This is due to it being made of die-cast metal which can easily break over time.

Our repair kit consists of a replacement bracket for the internals of the button. Replacing this instead of the entire button is not only cost-effective but also provides a more reliable long-term solution as the OE button regularly fails over time. Our improved design is made from billet stainless steel making it stronger and reliable.

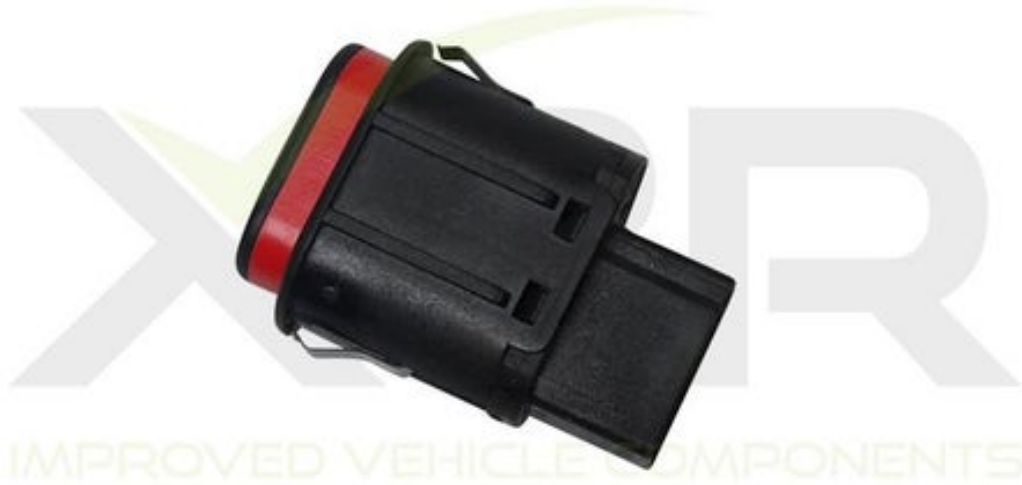
Step 1: Remove the Button From the Vehicle

Removing the button varies depending on vehicle model, but they are mostly found on the base of the seats. Ensuring the vehicle is turned off, pull the plastic trim away from the seat to expose the back of the button. Disconnect the electrical connector from the back and gently push out the whole button.

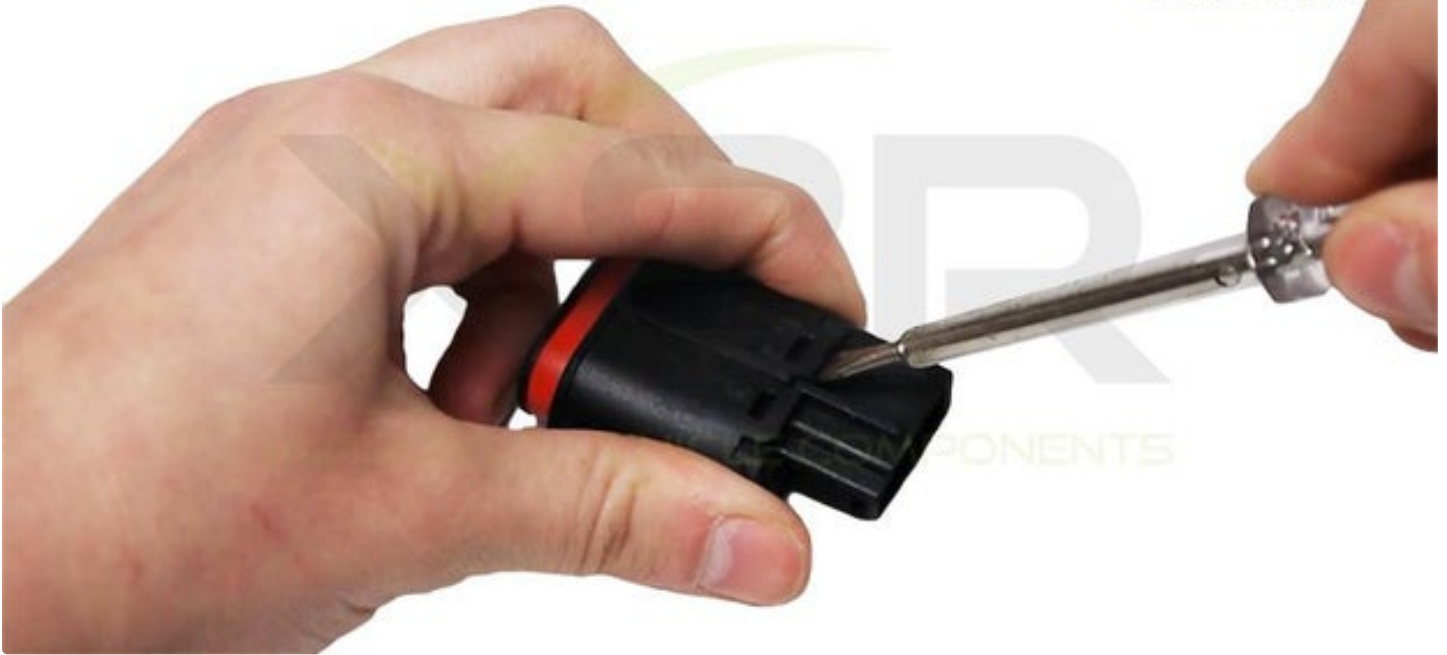
Step 2: Split the Button Open

Taking the flat head screwdriver, prize it between the plastic connectors and separate the button into two halves. Do this carefully ensuring you do not break the plastic housing on the button.

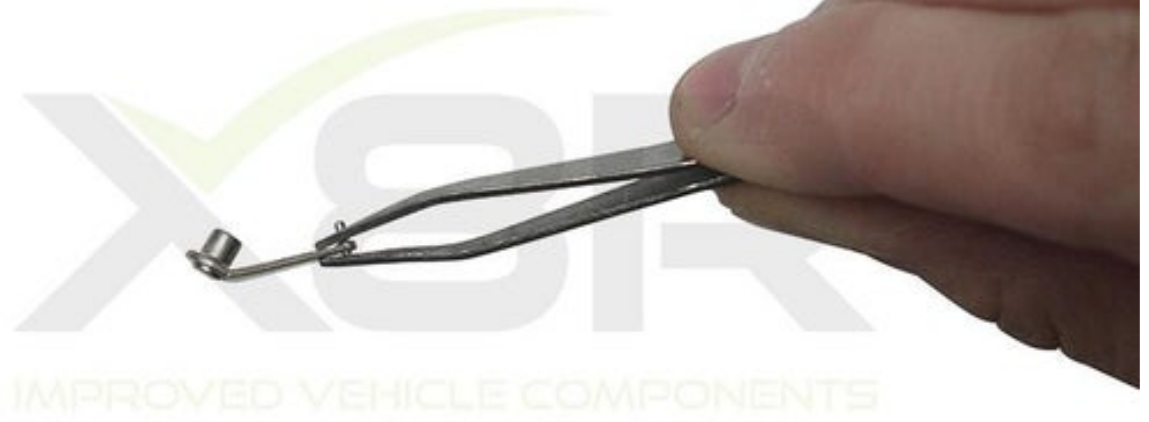
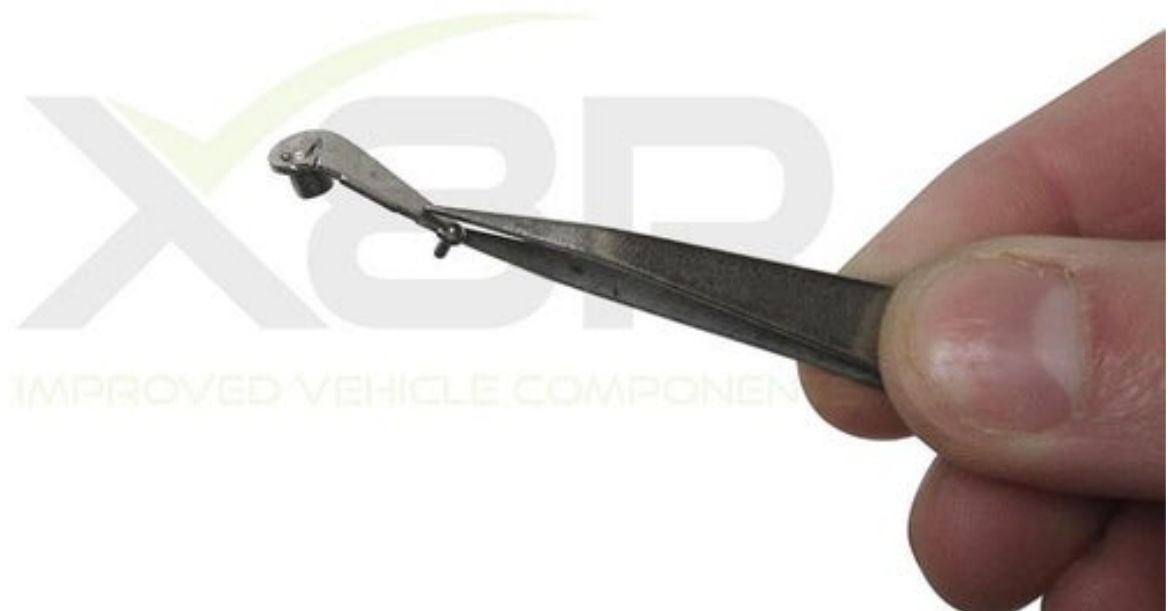
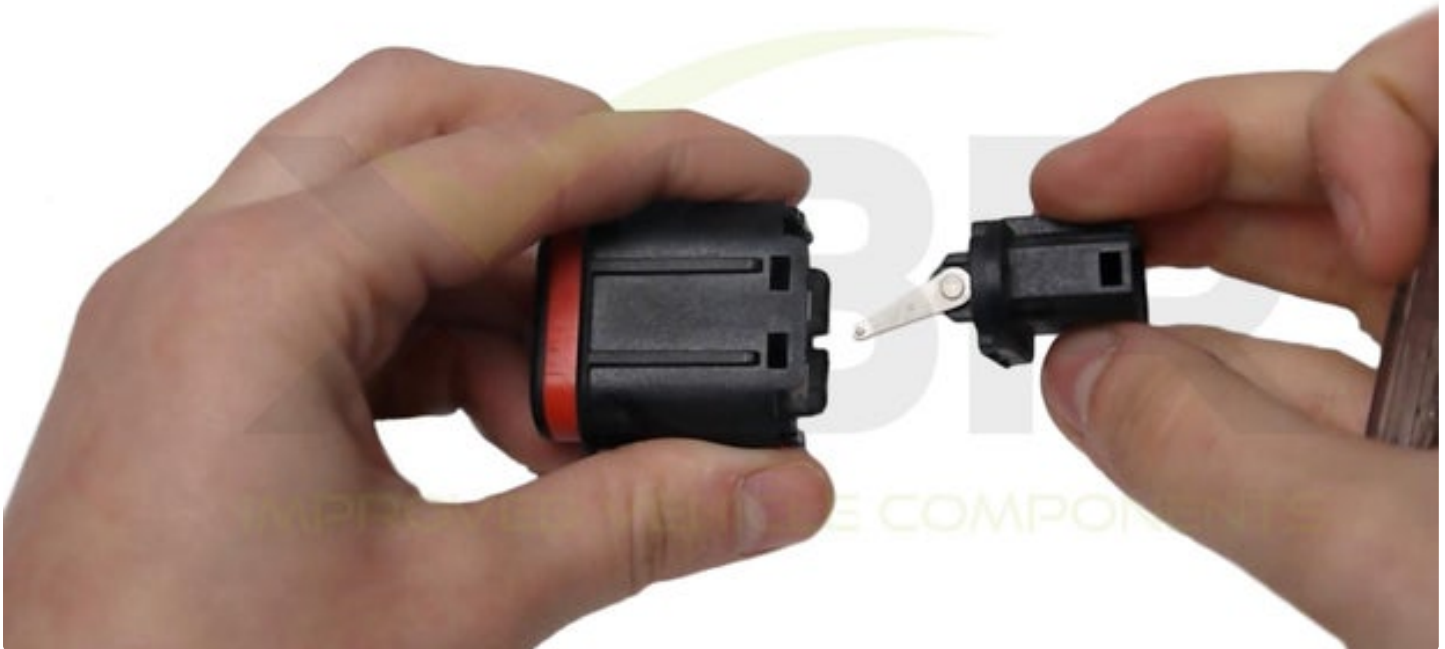
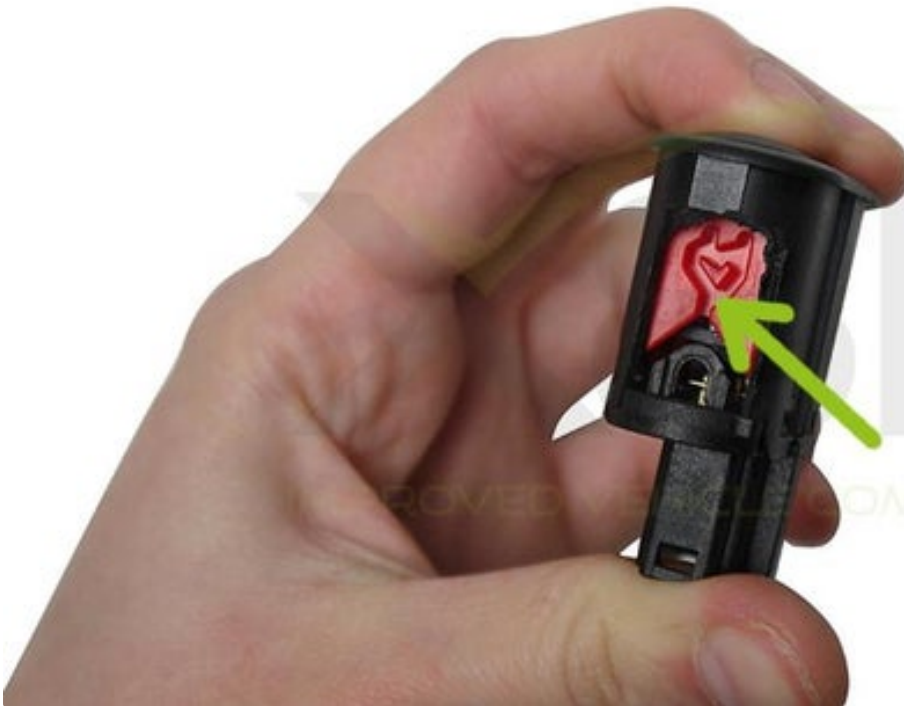
Step 3: Replace the Lever

After splitting the button open you will see the old lever, which is most likely bent or snapped. Replace this with the new X8R lever by slotting it in the gap where the old lever was, ensuring that the new lever has slid into the mechanism correctly so the button can be pressed down.

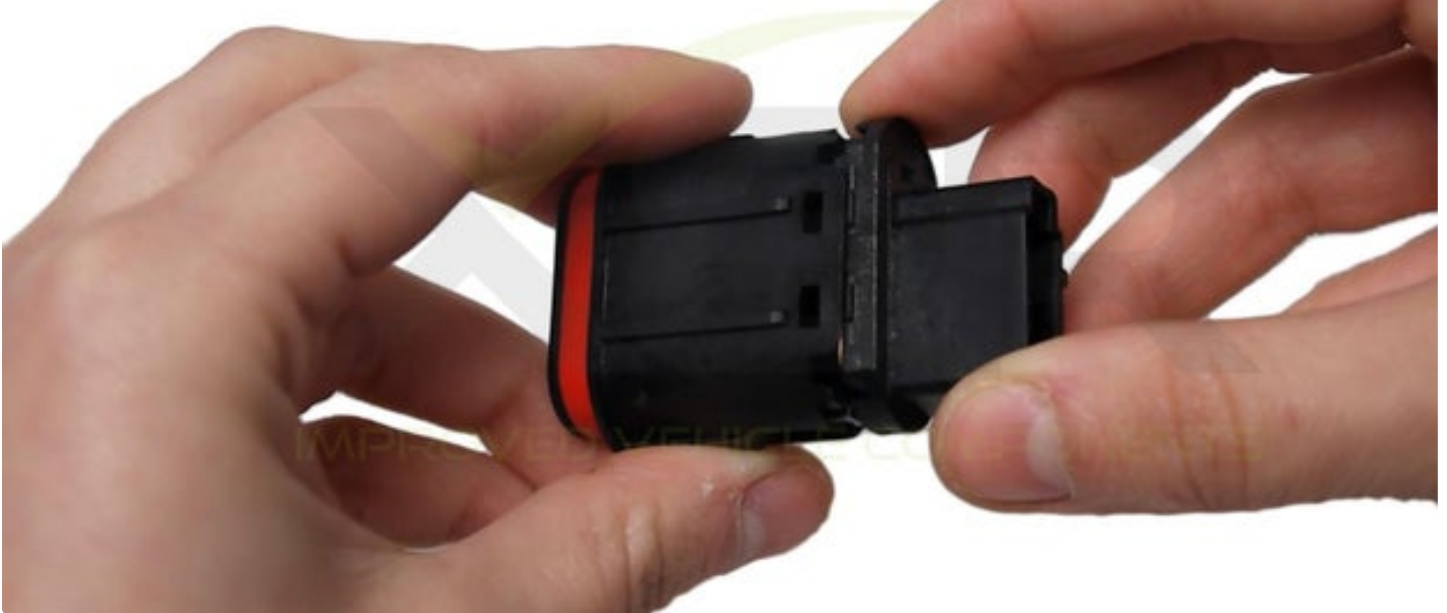
Step 4: Put the Button Back Together

While holding the new X8R lever in place, guide the bottom half of the button back into the top half, making sure the lever goes into the open section. Push it until you hear a click on both sides.

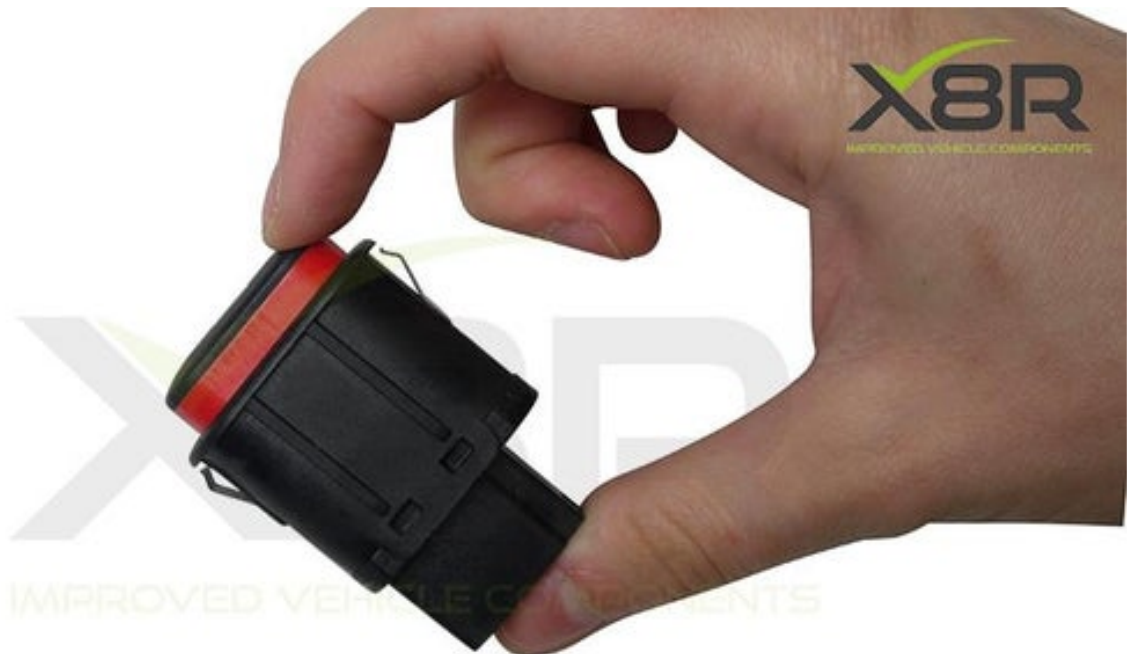
Step 5: Try It Out

Give it a few clicks to ensure the new lever is secure & operational, and it is ready to be fitted back into the vehicle.
